2013 Surface Mining Inspection Report
Robertson's Ready Mix
Banning Quarry
CA Mine ID# 91-33-0012

December 30, 2013
Project No. 4212-MI

Subject: 2013 Surface Mining Inspection Report
Robertson's Ready Mix "Banning Quarry"
CA Mine ID# 91-33-0012
City of Banning, Riverside County, California.

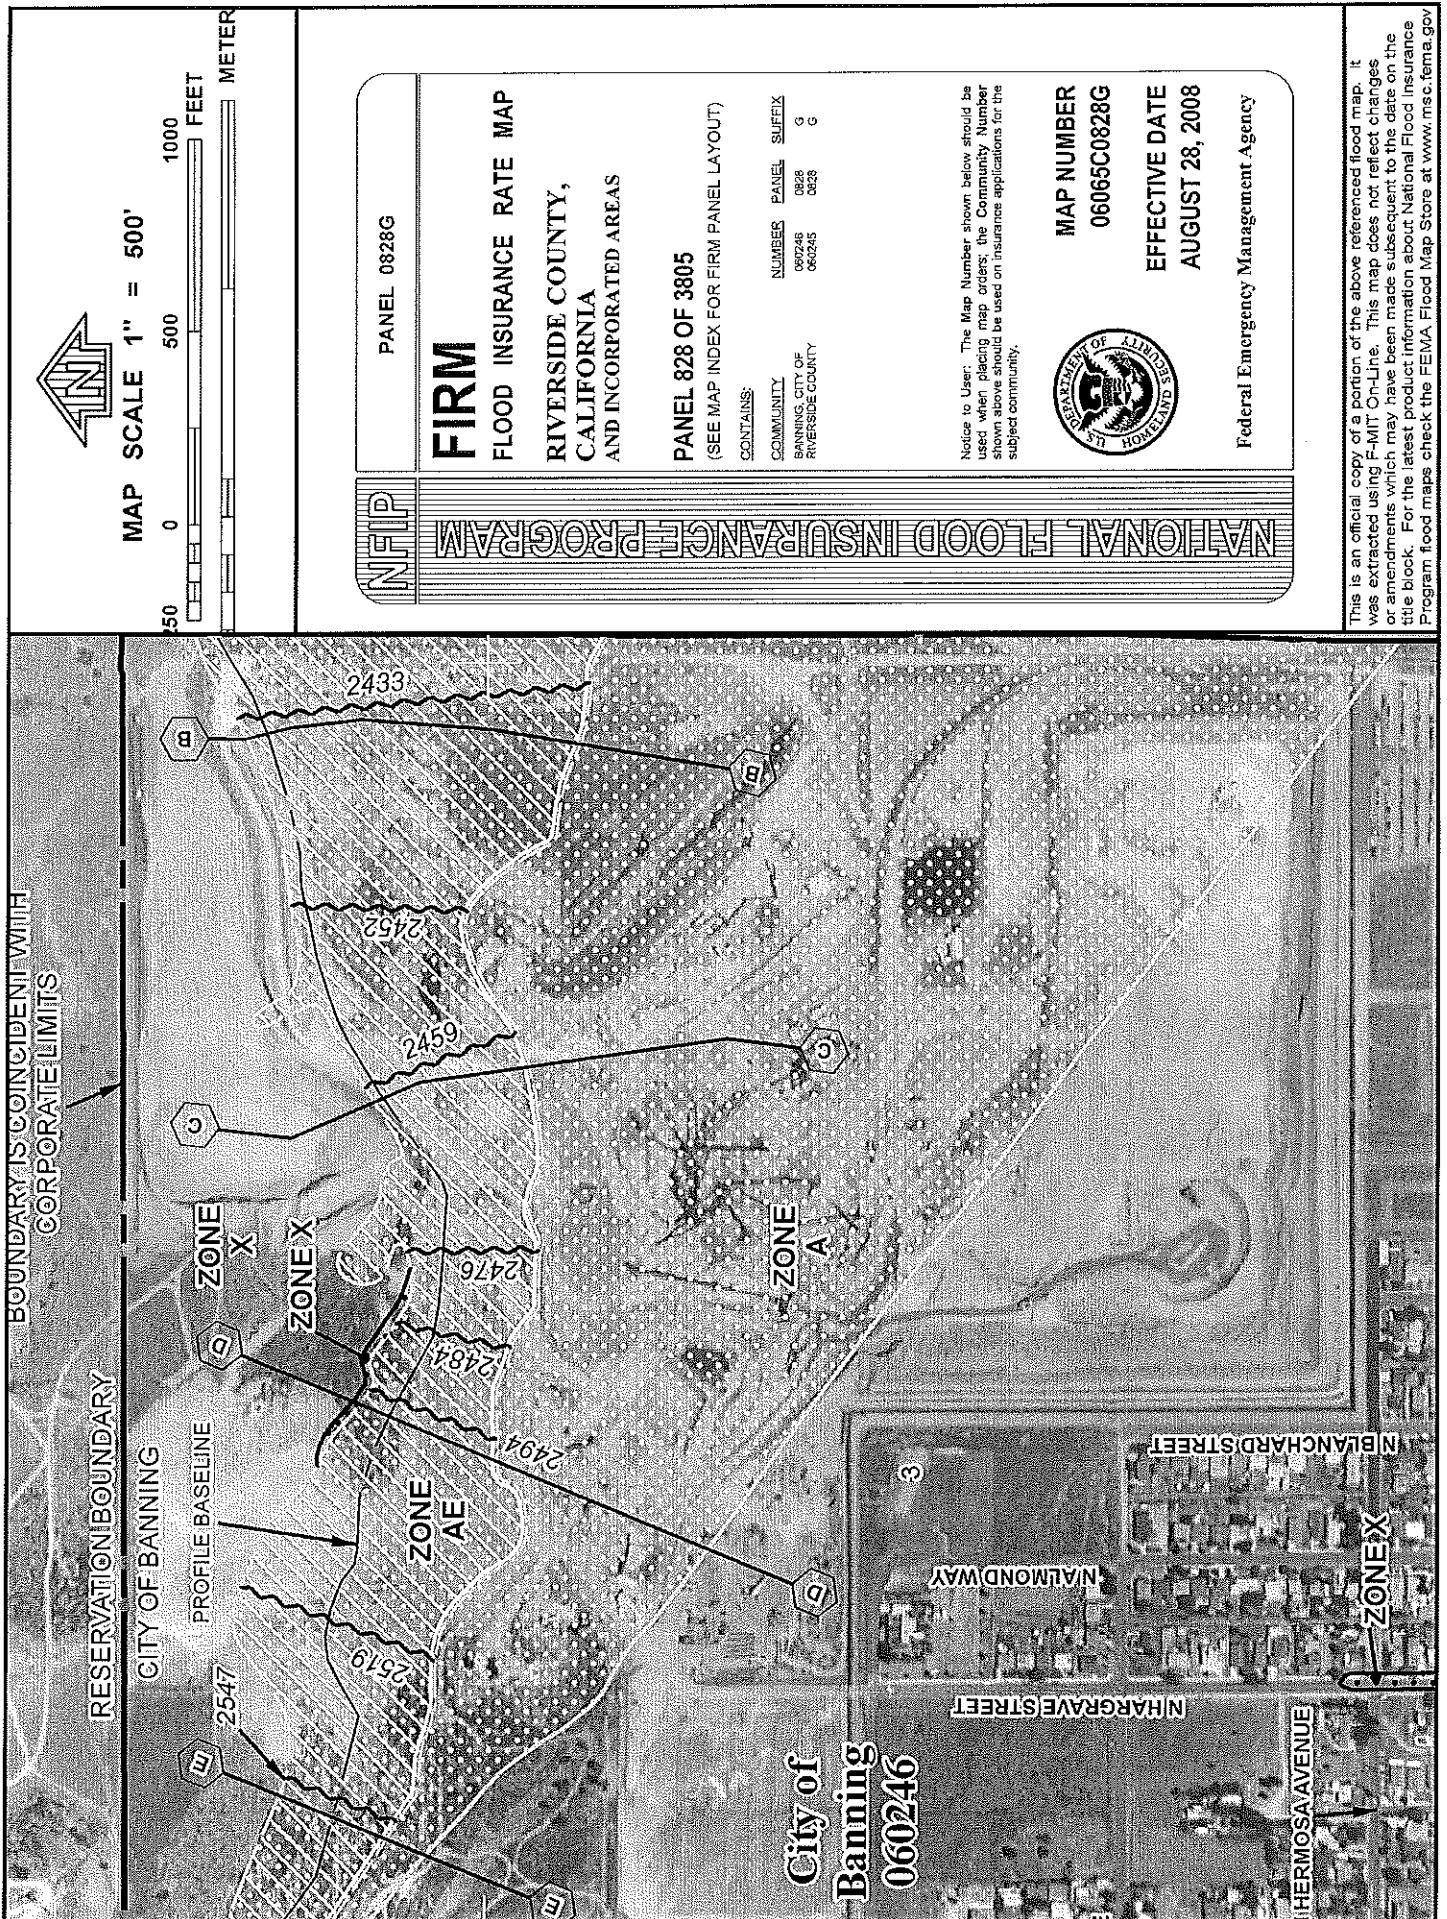
Figure No. 3, Flood Zone Map

The greatest uncertainty currently lies with the design and condition of the right-bank dike along the San Gorgonio River. The City of Banning does not have reports indicating the dike is an engineered feature with controlled compacted fill. The crest width is locally less than specified in the (old) vested-mine reclamation plan, and mostly lacks erosion protection on its stream side. Failure or overtopping of this feature would potentially flood the West or East pits (and/or future resource excavations after processing plant relocation). Avulsion would be accompanied by upstream knickpoint migration and renewed headcutting in the streambed. It is not known whether this could create risk to the Banning Levee.

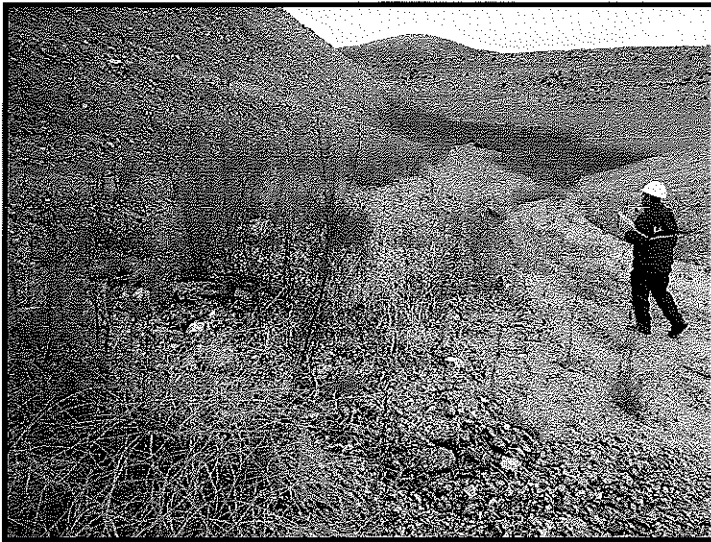
Photo 1: West pit, view north toward northwestern re-entrant corner. Engineered slope trimming has created smooth 1:1 bench face slopes with ~12-foot-wide benches. Since 2012, spring water inflows have almost completely ceased (former pebbly streambed in foreground is dry). Winter rainfall the previous season was near a historic low, however, and we expect surface flows in most years. No work has been done since previous inspection to control slope erosion or piping in the corner. Some floor areas of the West Pit appeared very recently mined, but inactive on the inspection date.

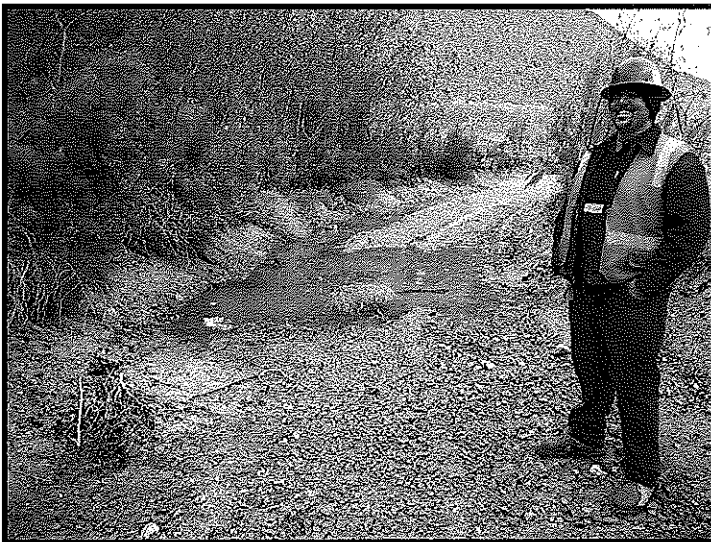
In 2012, AGI observed significant groundwater discharges in the northwest corner of the West Pit. The springs had all but dried up by the time of the 2013 inspection. Only a small puddle near the slope toe, and rather dense tamarisk seedlings, hinted at what was still very moist ground between the slope toe and the discharge points high on the pit slope. The previous rainfall season was one of historically low precipitation. Spring discharges are a result of a fault zone barrier created by the San Gorgonio Pass Fault (Section 6.1). The fault separates the Cabazon and much shallower Banning Bench groundwater storage units (Geoscience, 2011). Since the time the inflows were first encountered during excavation, water has generally been

Photo 2: West pit re-entrant corner, view northeast. The only open water in the area was this small puddle at toe of slope. The large pond east of this highwall was dry. Comments were made to the operator and their Reclamation Plan agent that the tamarisk colonizing the slope was considered a noxious weed and should be controlled in the future.

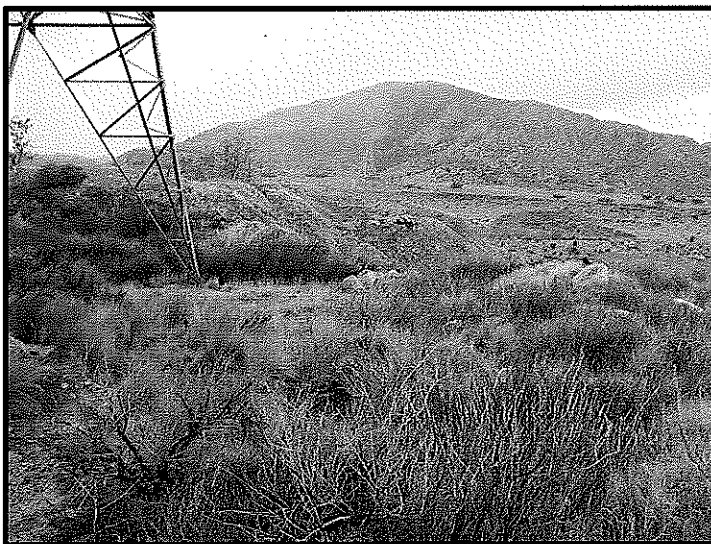
The southwestern sidewall slope is oriented parallel to four overhead Southern California Edison 220kV transmission circuits (Devers-Vista #1 and #2; Devers-San Bernardino; Devers-El Casco). One steel tower for Devers-Vista #1 and #2 was measured during the current inspection to be only 17 feet from the slope brow at the northernmost leg. The nearby cuts are rough, fluted, steep (locally $\sim 3/4:1$), and lack non-erosive facings. Slope height according to new topographic maps is 100 feet. Loose berms appeared to be the only protection from over-the-brow storm runoff. The transmission tower appears to be supported by typical cast-in-drill-hole pile foundations at each corner, with unknown depths of embedment.

One SCE electrical transmission tower is very close to the East Pit. One tower leg is only 17 feet from the brow of a 100-foot-high oversteepened slope. AGI's opinion is that the tower may have a non-trivial risk of toppling due to slope failure in a major earthquake. Although local damages would be severe, abrupt circuit losses could wreak incalculable damages if automatic system shutdowns proceed across SCE territory and a regional power outage results.

Photo 3: Devers-Vista #1 and #2 tower leg, adjacent to East Pit. Distance from the tower leg to the brow of a 100-foot-high descending cut slope (out of view) was measured at 17 feet. Foreground vegetation could be representative of “natural” conditions, as the tower footprint is one of the very few and very small areas of undisturbed ground.

2012 Recommendation: The City should compel **immediate** abatement of unstable slope hazards next to the SCE tower in the East pit, if a quantitative analysis by a qualified professional (geotechnical engineer or engineering geologist) indicates the present slope is steeper than the critical gradient and also presents risks to the electric circuits. Abatement could be technically challenging. For example, sediments in the East pit are probably not suitable as a bearing medium for a stabilization fill, if this option were to be considered.

No analyses have been submitted concerning interpreted hazards next to the SCE tower. Although it is acknowledged that the tower will someday be replaced, the timing of this action still leaves a significant exposure period with risk of loss (if the slope is in fact dynamically unstable). Conditional probabilities for a large earthquake in the Pass region are high. We think the Lead Agency must demand the previously recommended quantitative analysis. Thereafter,

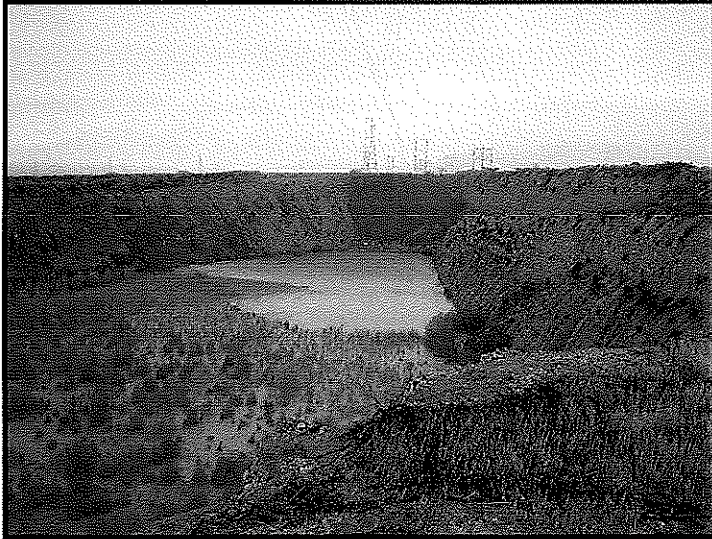
Photo 4: East Pit, view south from SCE easement. The eastern pit wall (left side) features loose soil slopes at natural angles of repose with some steeper projections of intact alluvial strata. The eastern slope approaches, but does not appear to cross, the property boundary with the adjacent Morongo Indian Reservation. This pit has been used for years as the disposal site for washed fines generated from the sand and gravel processing plant. Interpretations of CUP 1965 reclamation plans and the latest-available contour maps indicate that at least 17 feet of sediment is beneath the pond, thickening to the north. The ¾:1 cut slope in the right half of the picture has stood for at least 30 years. It has experienced some deep rilling and exhibits relatively sparse vegetation. It is believed this slope will be mined to pond elevation. Pondered water evaporates, or infiltrates into the excavation sidewalls.

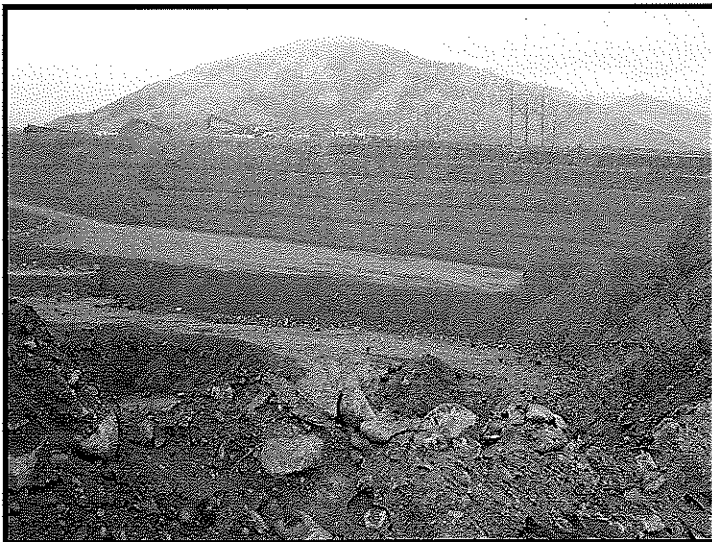
Photo 5: South Pit, view north. The northern pit wall has undergone slope trimming with a dozer and slope board, to create a benched surface with benches estimated at 20-foot intervals. The South Pit has been the primary aggregate source for the last year.

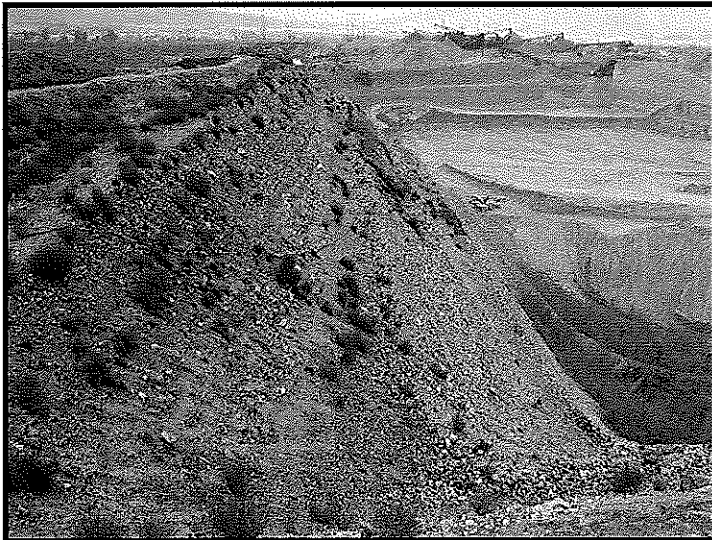
Photo 6: West Pit, view east along the northern highwall to show start of natural vegetation restoration. Noted that benches are becoming indistinct under a surficial cover of loose talus. Dense tamarisk is present where perennially saturated ground has been experienced due to spring flows (lower right). Pit bottom shows evidence for some extraction. Future resources continue east, under the existing plant site. The operator affirmed that relocation of the processing plant to the bottom of the South Pit is planned and will be documented in a new site-wide Reclamation Plan.
