2013 Surface Mining Inspection Report
Robertson's Ready Mix
Banning Quarry
CA Mine ID# 91-33-0012

December 30, 2013
Project No. 4212-MI

Subject: 2013 Surface Mining Inspection Report
Robertson's Ready Mix "Banning Quarry"
CA Mine ID# 91-33-0012
City of Banning, Riverside County, California.

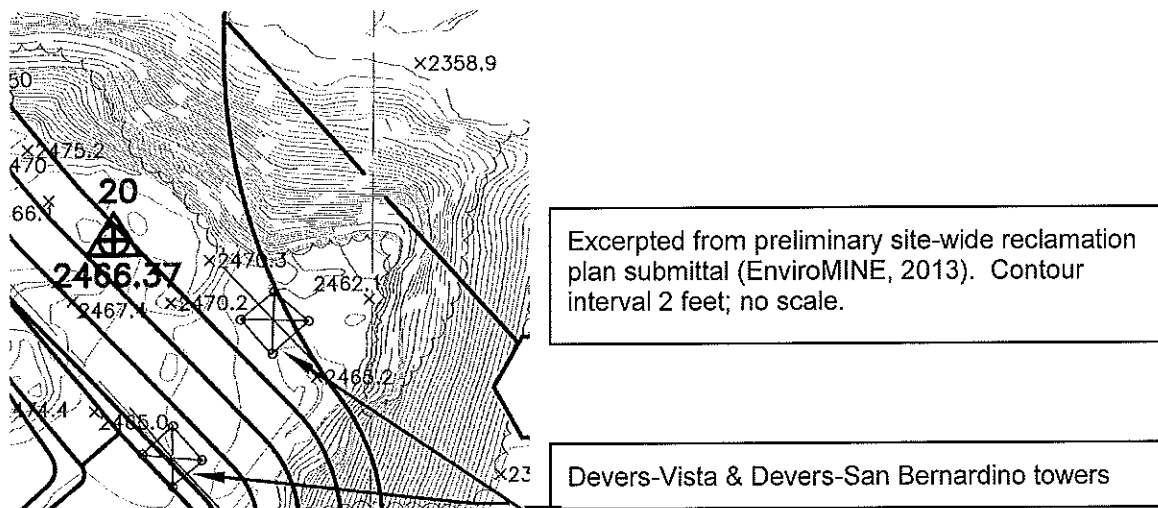
The southwestern sidewall slope is oriented parallel to four overhead Southern California Edison 220kV transmission circuits (Devers-Vista #1 and #2; Devers-San Bernardino; Devers-El Casco). One steel tower for Devers-Vista #1 and #2 was measured during the current inspection to be only 17 feet from the slope brow at the northernmost leg. The nearby cuts are rough, fluted, steep (locally $\sim 3/4:1$), and lack non-erosive facings. Slope height according to new topographic maps is 100 feet. Loose berms appeared to be the only protection from over-the-brow storm runoff. The transmission tower appears to be supported by typical cast-in-drill-hole pile foundations at each corner, with unknown depths of embedment.

AGI was informed during the site inspection visit that SCE personnel had viewed the tower's proximity to slopes. SCE is reportedly pursuing a transmission line upgrade program that would relocate all circuits to one larger tower outside of the depicted plan excerpt. The upgrades are under Federal review. The mine operator and their reclamation plan consultant speculated that the new line might not start construction for at least two to three years, however.
